PROJECT HISTORY

CITY OF GRANT CITY

GRANT CITY, MISSOURI

“Shot-crete Job Gone Wrong”

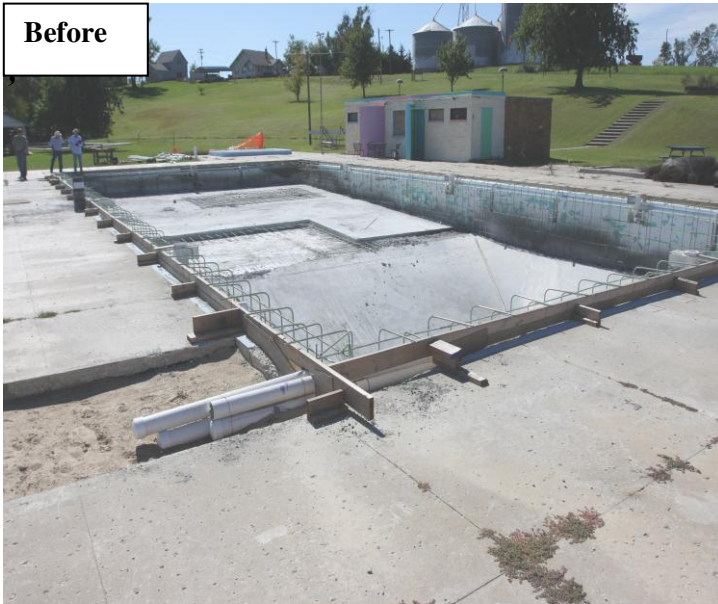
Before

Grant City, Missouri determined that their city’s formed and poured concrete pool was badly cracked and the surface very deteriorated. Not having been properly winterized and constructed with metal piping, the city also opted to have the old circulation lines replaced with PVC. The existing shell of the pool was kept, acting as a ‘form’ for the new, slightly smaller pool. A contractor was hired to rebuild the pool. However during placement of the new concrete, several surprises occurred: The concrete order was greatly underestimated, delivery to this small city from a small concrete plant took over an hour per truck, cool / cold weather hampered placement and there was an inability to ready more concrete as needed to finish the placement as darkness approached

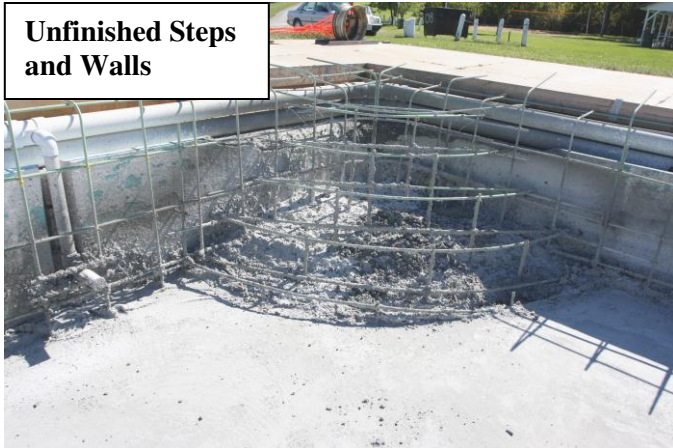
**Unfinished Steps
and Walls**

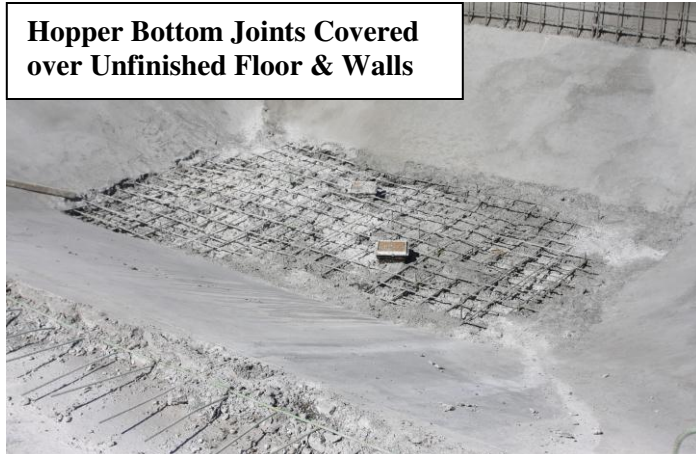
**Hopper Bottom Joints Covered
over Unfinished Floor & Walls**

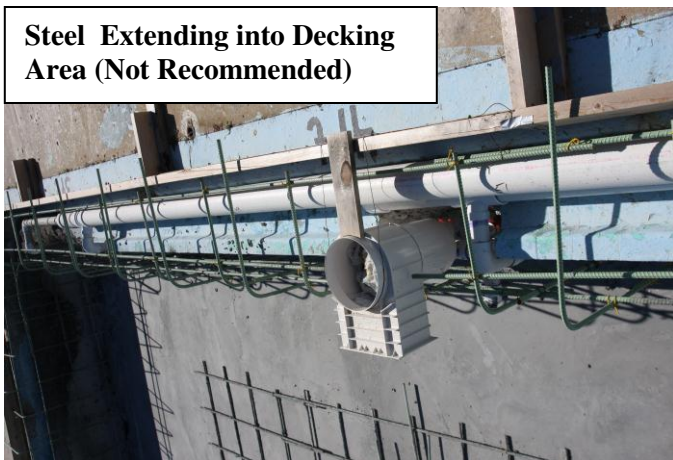
**Steel Extending into Decking
Area (Not Recommended)**
