# ROCK SPRINGS 4-H CAMP – HISTORIC RESTORATION PROJECT

JUNCTION CITY, KANSAS

COMPLETION: 2013

## PROJECT ASSESSMENT

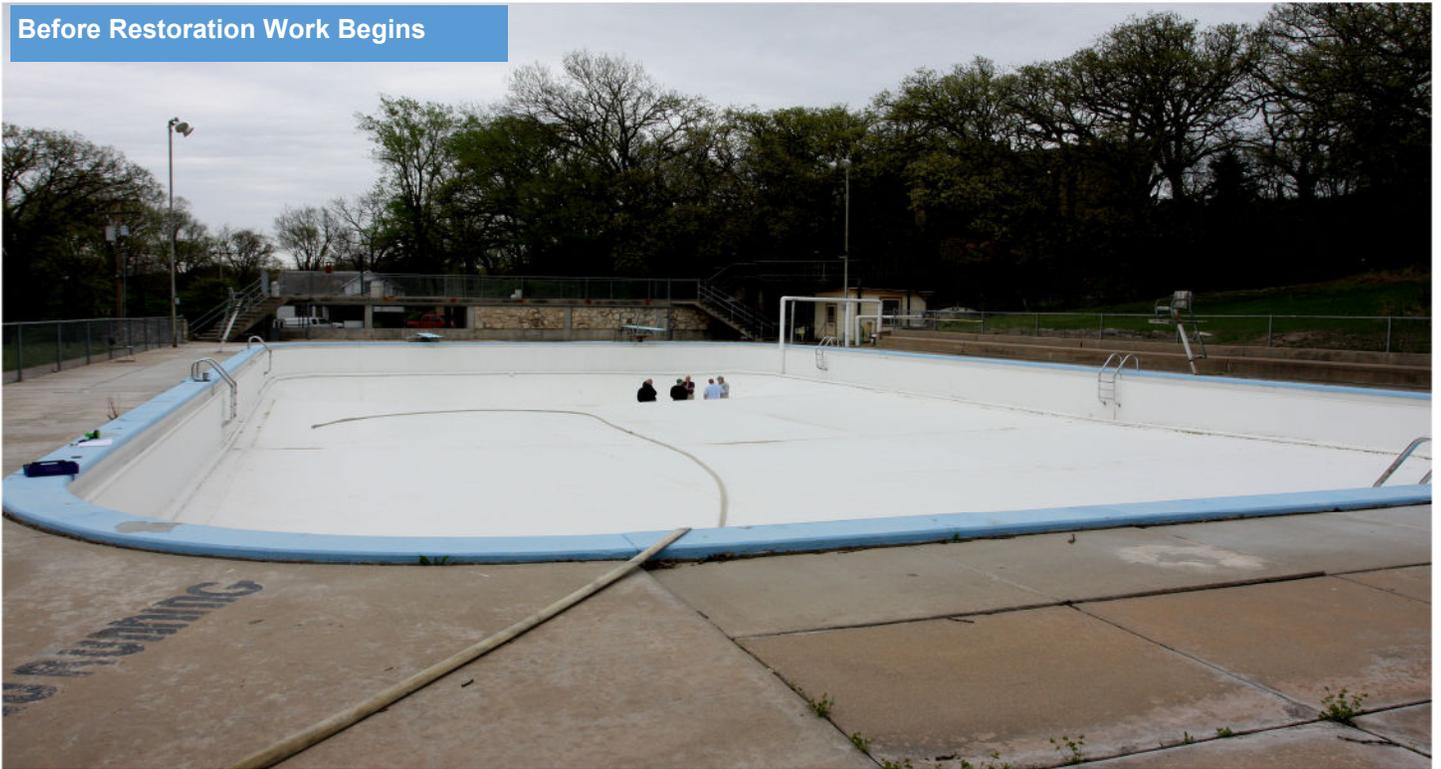
Before Restoration Work Begins

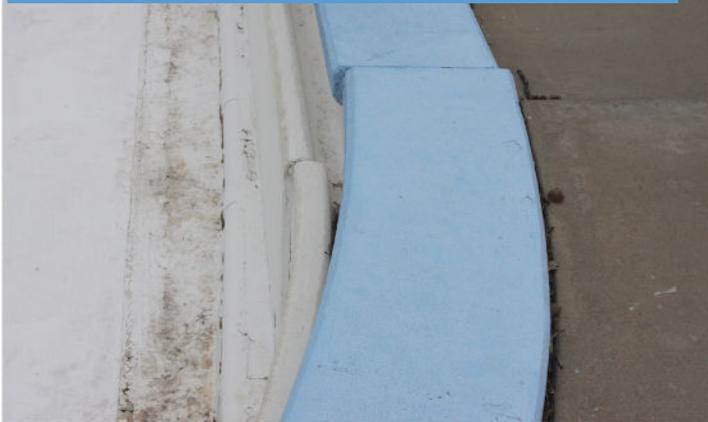
Sectional Concrete Gutter & Coping Cap Movement

Before Stainless Steel gutter installation, adjustments had to be made to the walls at the sectional joints. While the walls were structurally intact, they experienced movement near the joints that caused them not to be ‘plumb’ with each other. Movement was generally restricted to the upper areas of the walls. Mechanical abrasion was used to rid the worse differences. Supporting stainless steel plates were added to the top (now cut portions) of the walls to restrict future movement. New decking included expansion joints that limited the concrete mass from pressuring onto the pool walls that would cause repeated irregularity.

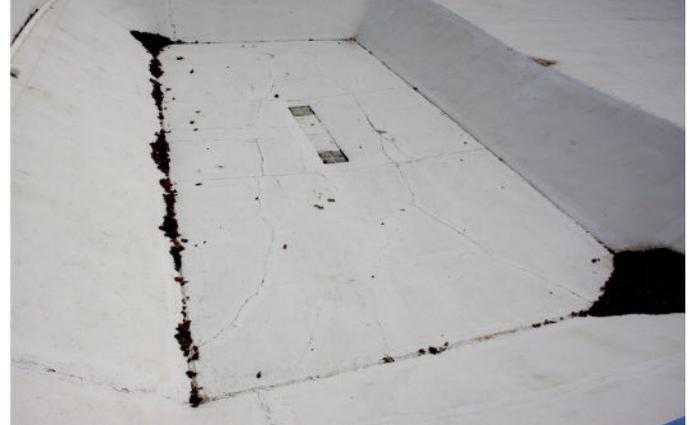
Turnover rates no longer met commercial standards. The existing diving well no longer met current diving and safety depth standards. Diving boards were roped off and not used. The concrete diving well suffered some of the worse freeze / thaw damage of the entire pool.

Freeze Damaged, Cracked & Outdated Diving Well

Because the diving well did not meet current depth standards for diving board use, plans were made to cut, remove and deepen the pool. That made poor Compressive Strength readings on the diving well floor irrelevant.

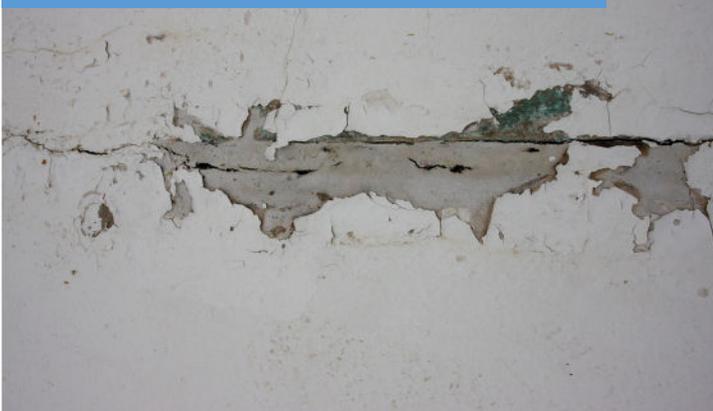
Peeling Paint off Expansion Joint Sealant

Abnormally wide (2” - 3”) expansion joints were covered with layers of pool paint, however the joint edges were straight and sound. Finding suitable material for such wide joints proved to be challenging, but not impossible.

Environmentally friendly Hydro-blasting (UHP) removed layers of pool paint and remaining caulking and bitumen expansion sealants.

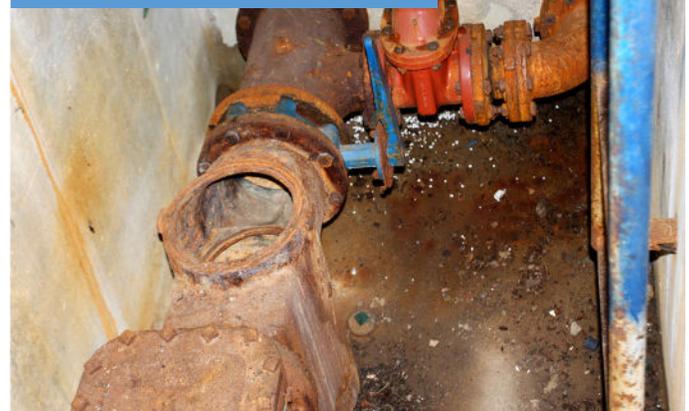
After years and years of use, structural movement and deterioration along with the effects of freeze / thaw cycling created large gaps between the sectionally poured concrete. Old steel piping used for the recirculation system rusted, cracked and did not function without leaking. The pool lost over 7,000 gallons a day.

Corroded Cast Iron Plumbing

SCH-80 PVC plumbing was used throughout and a new 20-Hp pump updated the recirculation system to current 6-Hour Commercial Turnover Rates.

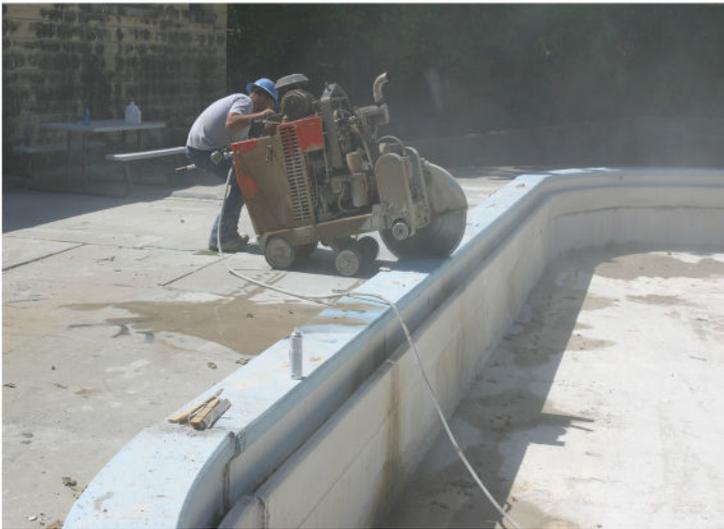
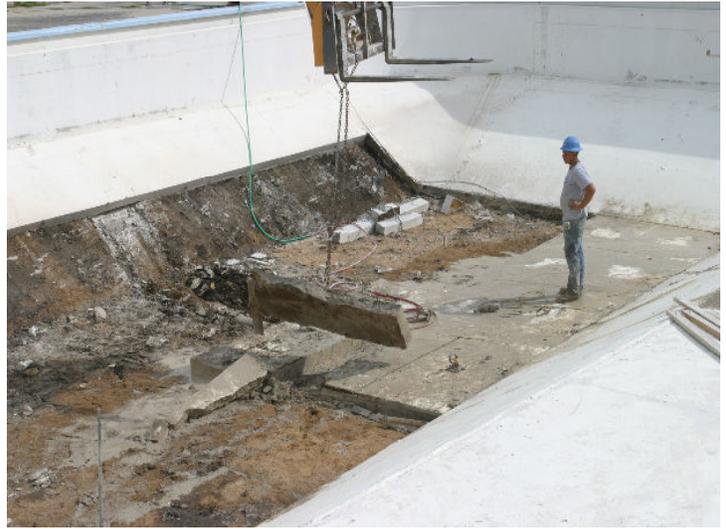
### Cutting Demolition and Removal of Sections of Concrete from the Gutter and Diving Well

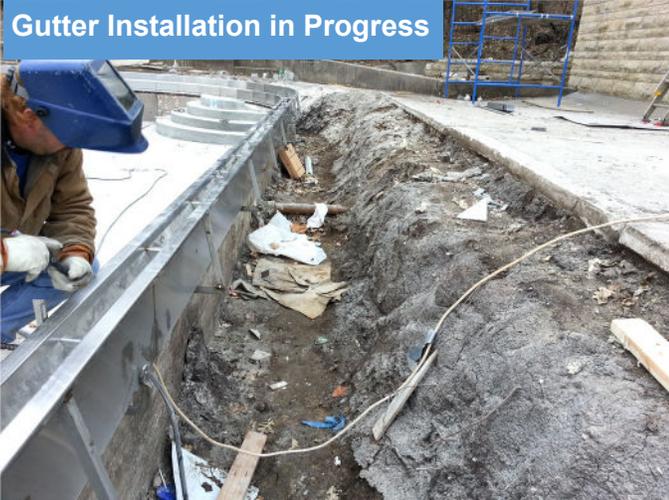
Gutter Installation in Progress

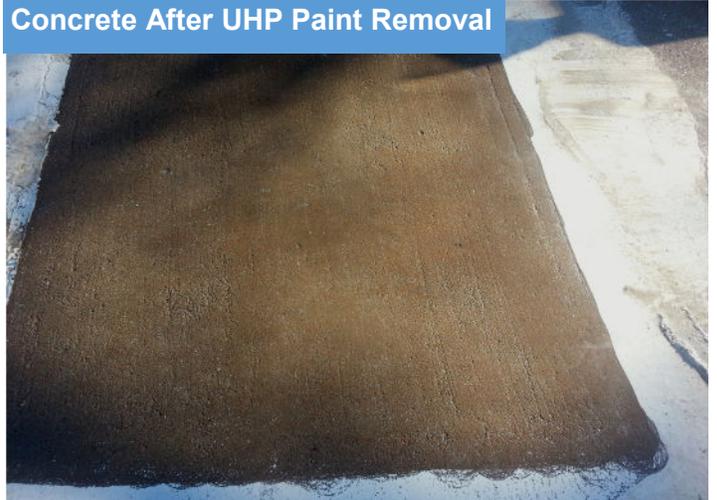
Concrete After UHP Paint Removal

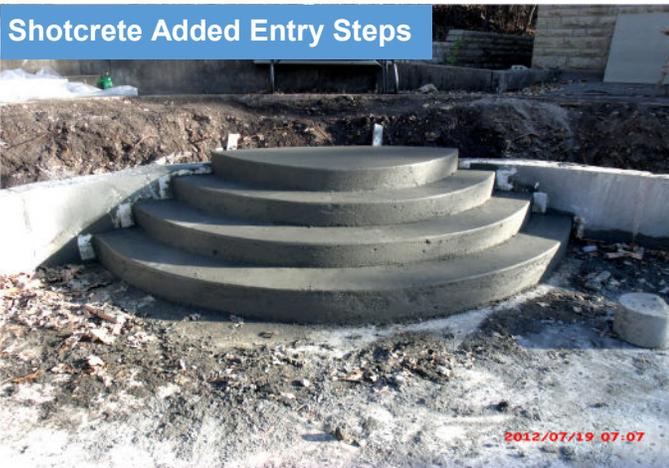
Shotcrete Added Entry Steps

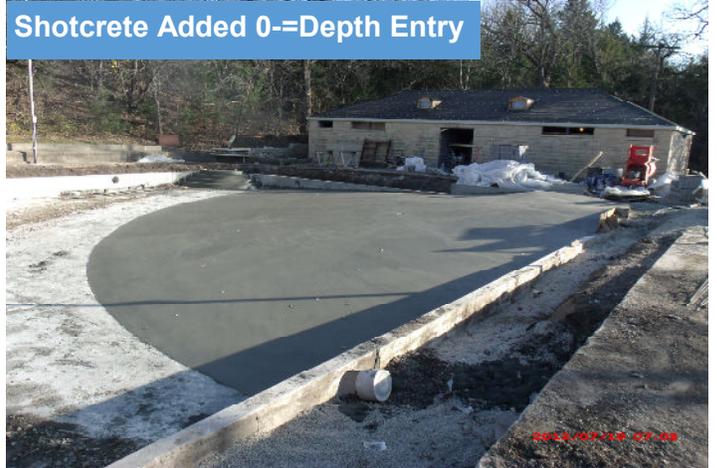
Shotcrete Added 0-Depth Entry

Lightweight fill was used below the reinforcing steel and shotcrete for the 0-Depth Entry.

Following excavation, shotcrete was used to construct the new diving well and 0-Depth Entry.

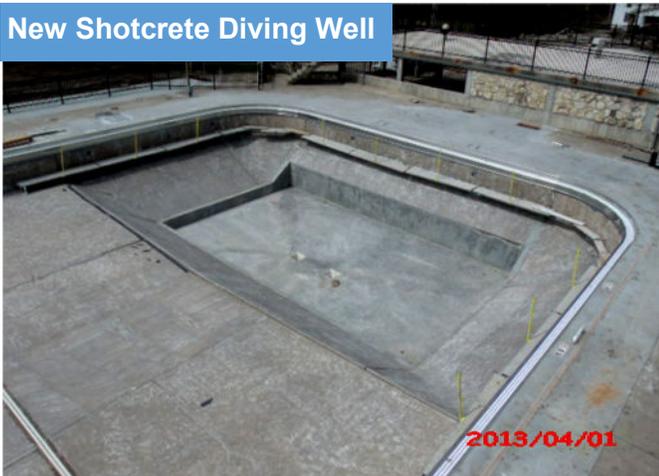
New Shotcrete Diving Well

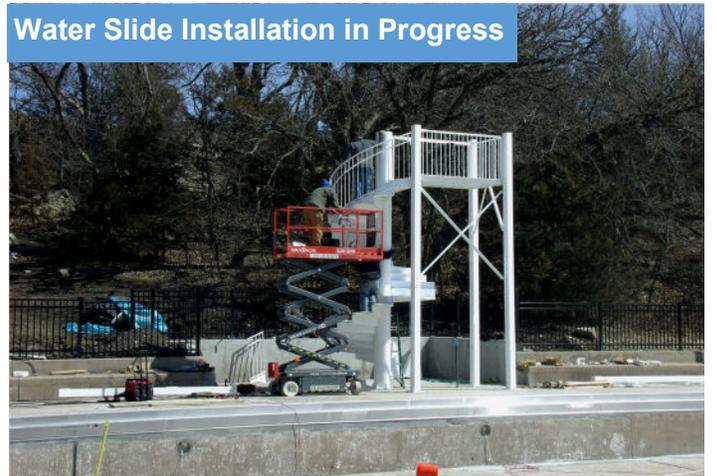
Water Slide Installation in Progress
