PROJECT HISTORY

BARLOW MOUNTAIN SCHOOL GUTTER RESTORATION

RIDGEFIELD, CONNECTICUT

COMPLETION: 2010

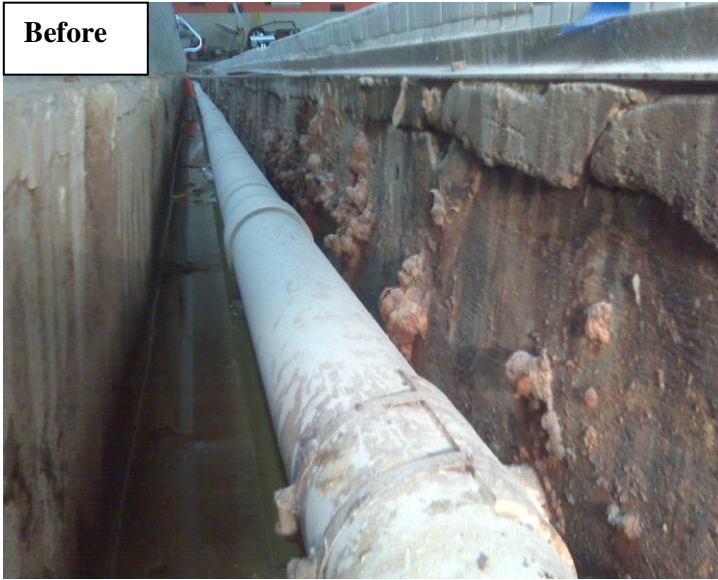
Before

During the course of re-surfacing the pool at the Barlow Mountain School, a random inspection was done of the concrete gutter that spanned the entire 260' perimeter of the pool. This inspection found severe concrete deterioration, concrete cover-cracking, reinforcement steel corrosion with iron oxide nodules depositing and penetrating out up to 2" en masse into the gutter channel from voids and cracks in the gutter's concrete walls. The existing 4" PVC return line was found to be brittle, worn and needing replacement. Even though only pool water entered the gutter channel, the surface of the gutter looked like a deteriorated wastewater treatment tank attacked by hydrogen sulfide.

Because of the severely damaged conditions in the gutter channel, a repair system had to be chosen to seal the cracks, fill the voids and inhibit further chemically treated water from penetrating into the concrete. Pitting and corrosion had to have occurred to steel reinforcement bars in the gutter walls. However the remaining steel had to be protected from further deterioration. Because of economic conditions and a low budget, the Town of Ridgefield, who owned the pool, had to work toward extending the life of not only the pool but also the gutter channel. Working in conjunction with the town's engineers,

Mid-America Pool Renovation, Inc. specified a wastewater materials repair system to perform the Work. This materials system included a microsilica cement mortar, a penetrating epoxy primer, and an ultra high build epoxy coating. The surface was cleaned, ground, and given a 6,000 psi water jetting with a rotational nozzle. Rust was cleaned off of all the exposed reinforcement steel and covered with Sika Armatec® 110. The channel was then re-surfaced with solvent free, high solids Epoxy Amine coating.

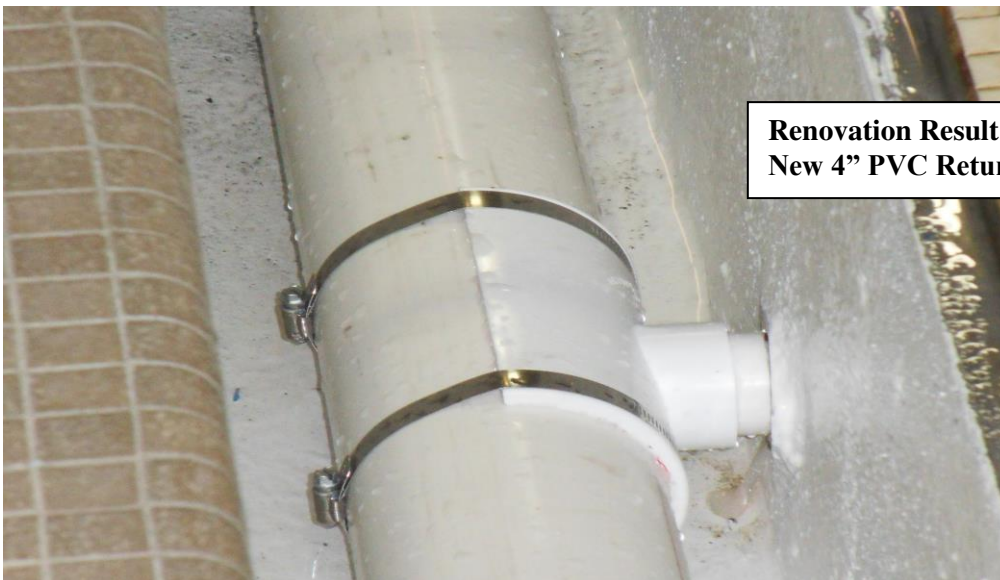
**Renovation Result: Gutter Channel Re-surfaced
New 4" PVC Return Piping In Place**

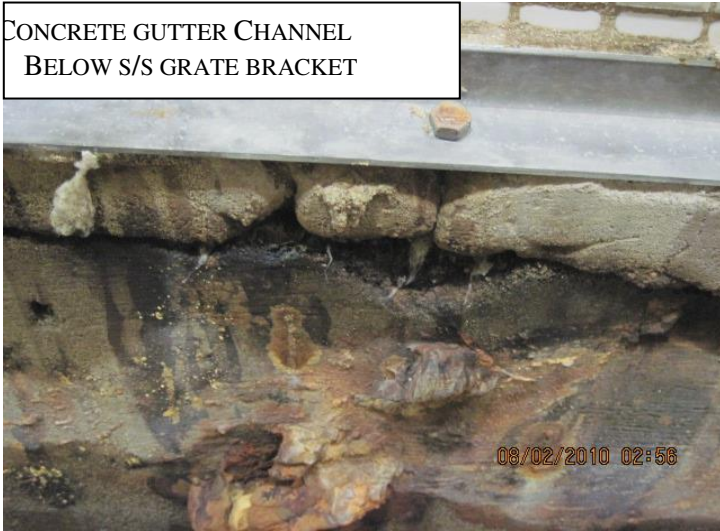
CONCRETE GUTTER CHANNEL
BELOW S/S GRATE BRACKET

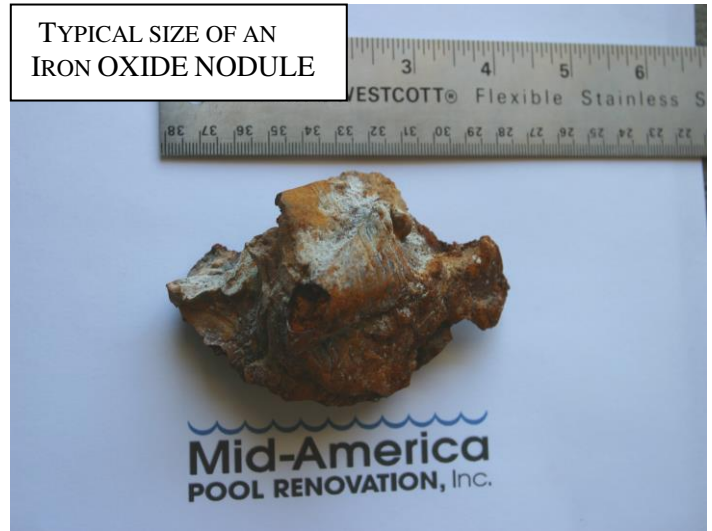
TYPICAL SIZE OF AN
IRON OXIDE NODULE

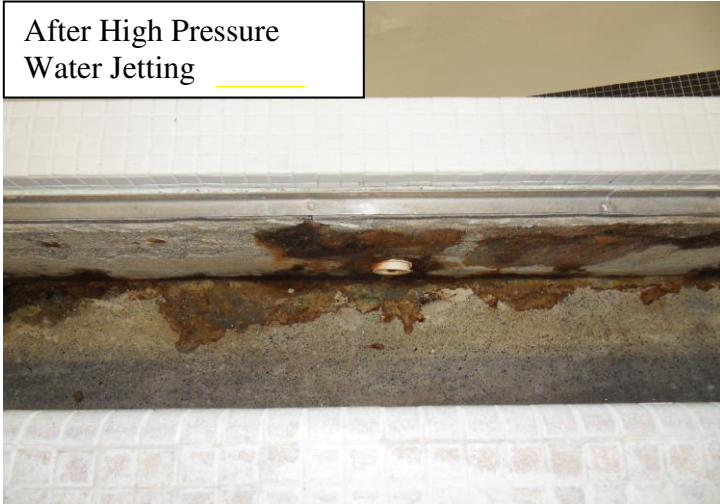
After High Pressure
Water Jetting

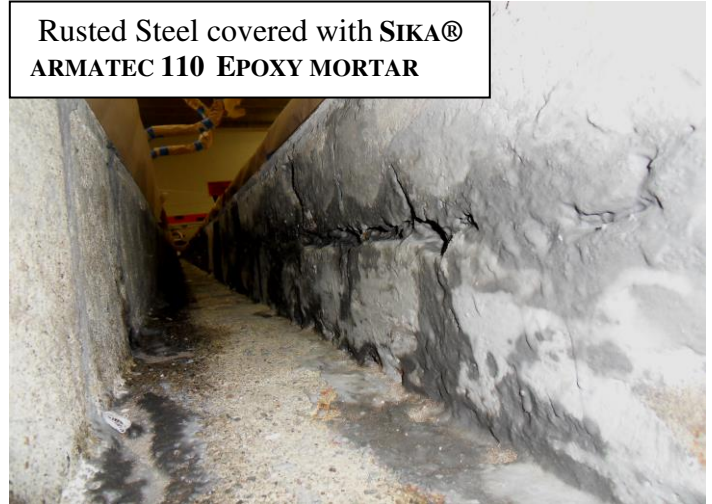
Rusted Steel covered with SIKA®
ARMATEC 110 EPOXY MORTAR

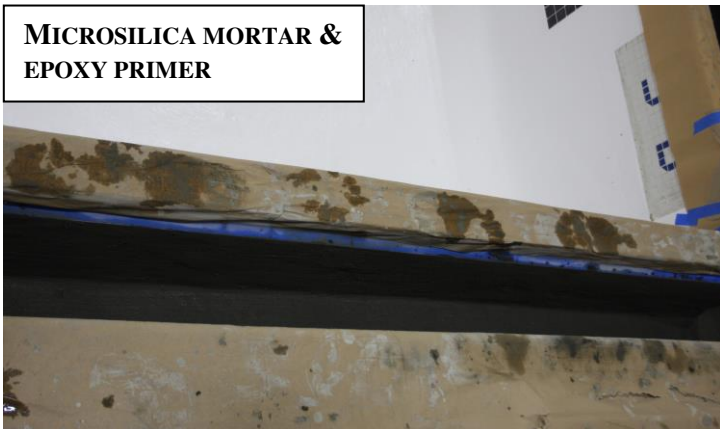
MICROSILICA MORTAR &
EPOXY PRIMER

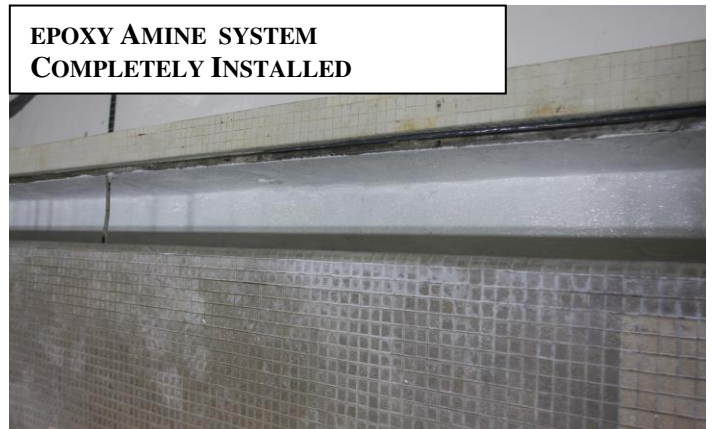
EPOXY AMINE SYSTEM
COMPLETELY INSTALLED
