# PROJECT HISTORY – **OUTDOOR WORK IN EXTREMELY COLD TEMPERATURES**

## SHERATON HOTEL – CROWN CENTER

KANSAS CITY, MISSOURI

COMPLETION: 2013

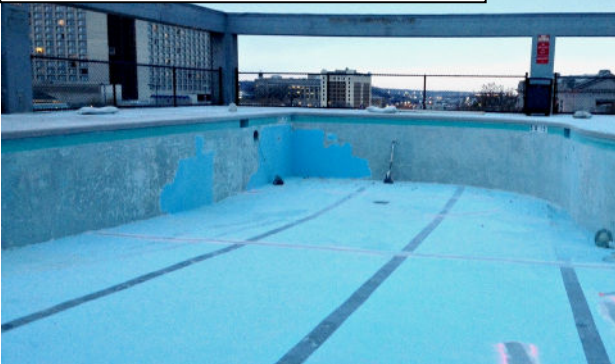
Paint Removal Underway

conditions without the use of any water. Pool paint was removed manually with every square inch of debris and residue hand vacuumed. The entire pool was tarped and heated with materials-friendly radiant heat. Cracks were routed, cleaned, injected with epoxy and permanently sealed with Aramid fabrics. Ceramic racing lane tiling was set. Finally, the entire pool was re-surfaced with INTER-GLASS®. The Project was successfully completed, pool filled with water and in operation a week before Christmas.

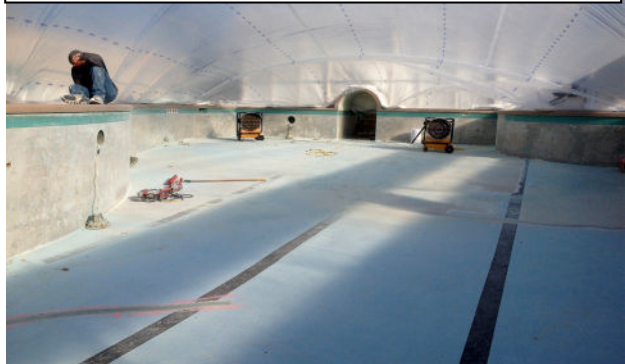
Structure Tarped, Radiant Heating Begins.

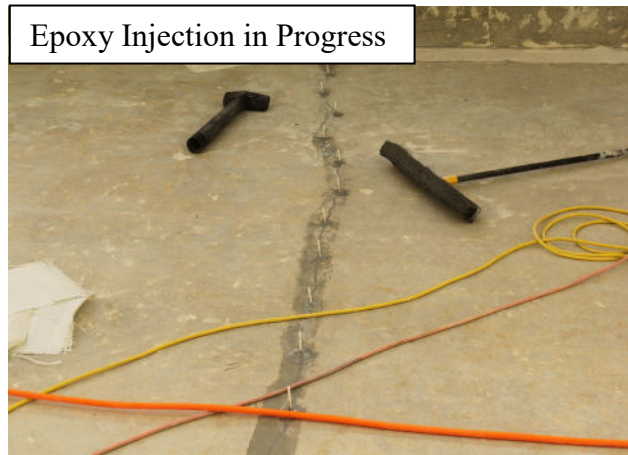
Epoxy Injection in Progress

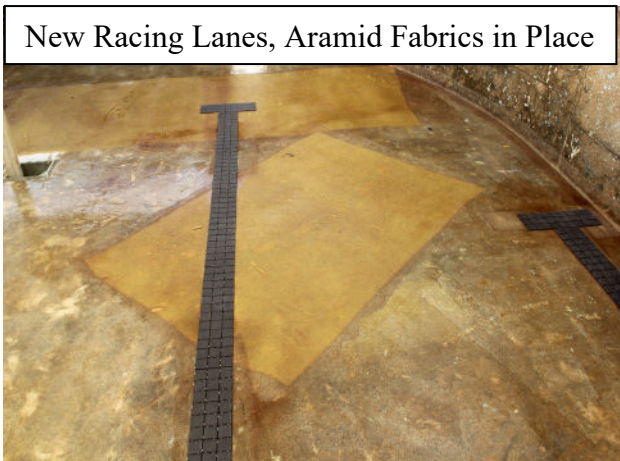
New Racing Lanes, Aramid Fabrics in Place

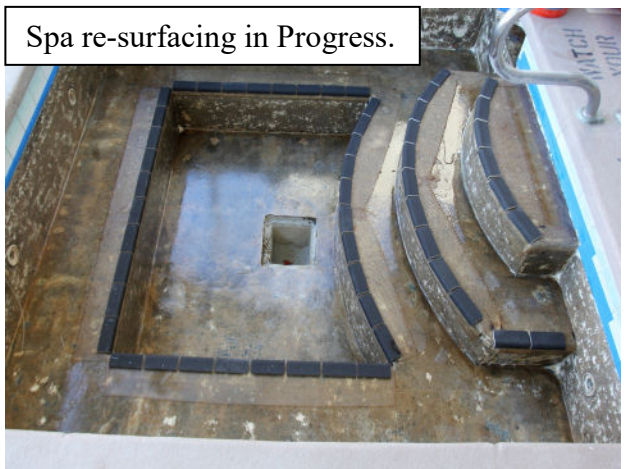
Spa re-surfacing in Progress.
