2012 Preservation Award Winner

# BEFORE HISTORIC RESTORATION PROJECT

# THE ELMS HOTEL & SPA – HISTORIC RESTORATION PROJECT

## EXCELSIOR SPRINGS, MISSOURI

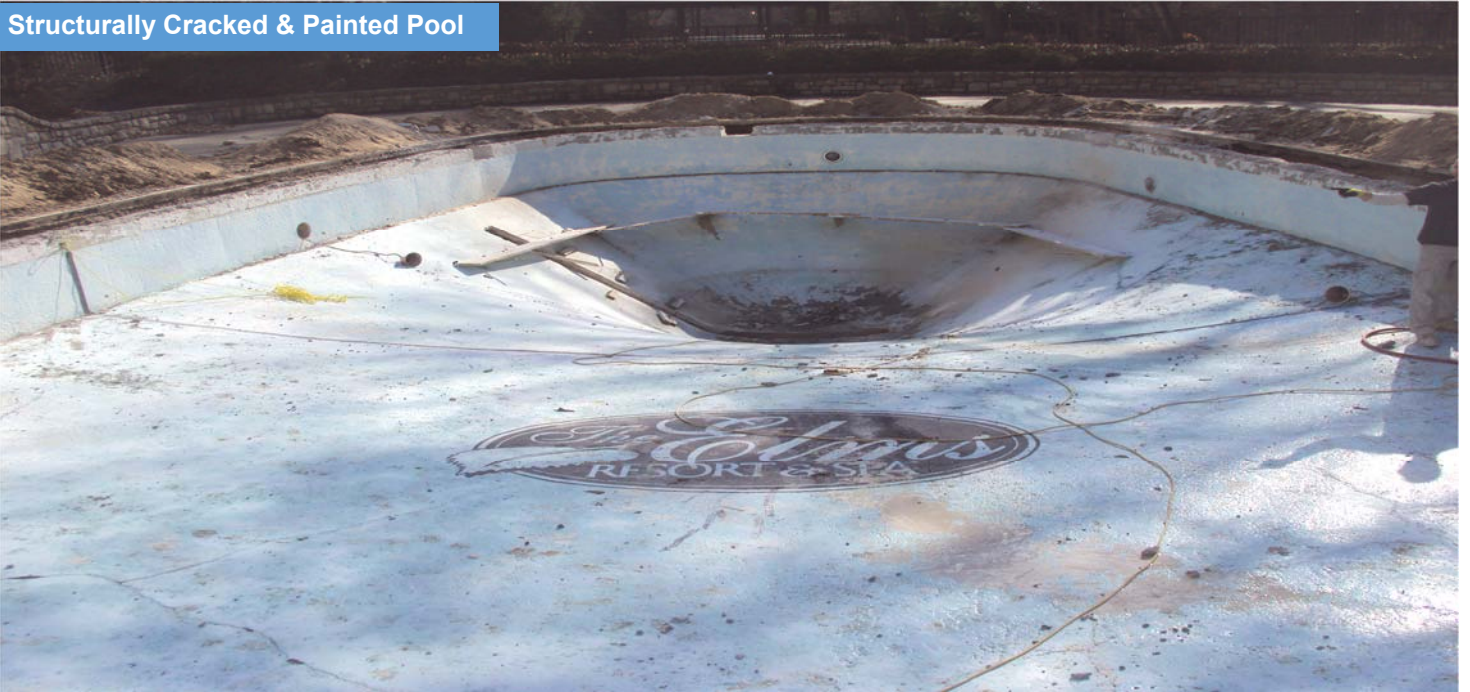
Having been painted repeatedly, the surface was peeling badly with structure cracks and Freeze / Thaw damage showing through the degrading finish. Aged recirculation lines were broken and leaking. Pool lights were outdated and needing replacement. Dated pool heaters, filters and pumps, all with temporary ‘Band-Aids’ were in disrepair. Poorly re-surfaced,

Structurally Cracked & Painted Pool

An important consideration with this Project was addressing structural issues in the outdoor pool and outdoor separate spa. Severe Freeze / Thaw damage and cracking affected both vessels. Pool paint was a failure in the main pool and not a considered as a solution with longevity in mind. Cement-based surfacing generally does not necessarily solve structural issues. Organic sealants such as those used in epoxy injection tend to reflect up through a new cement pool surface producing a 'zebra-effect'. While more costly, a polymeric surface serves to seal the cracking and stop the possibility of sub-surface reflection from crack repair materials. These considerations led to the INTER-GLASS® system being chosen on the outdoor pool and spa. Keeping with the Architect's design choice, the outdoor spa received a total tile finish using the INTER-GLASS® system. The entire pool equipment room was gutted. Old equipment and the patch-quilt of PVC recirculation line repairs were removed. New PVC lines were installed in the trenches and run into the equipment room. Once the lines were set in the equipment room, separate Pressure Tests were placed on

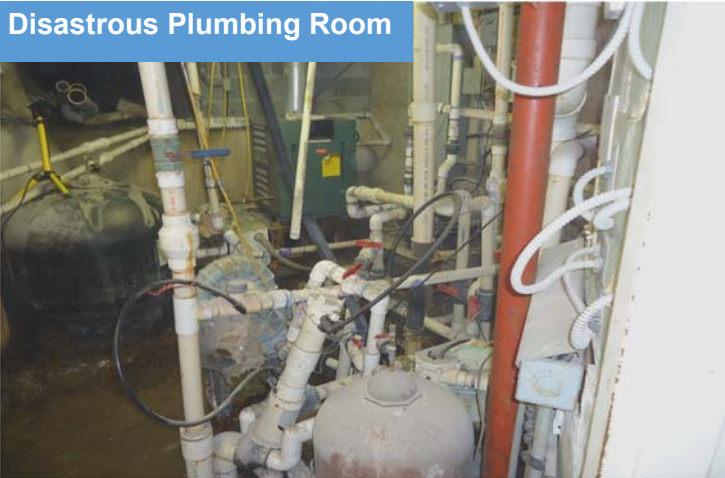
Disastrous Plumbing Room

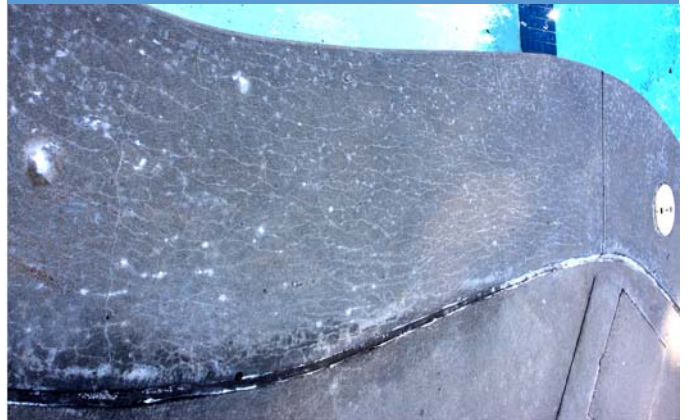
Expandable Aggregate Damaged Concrete

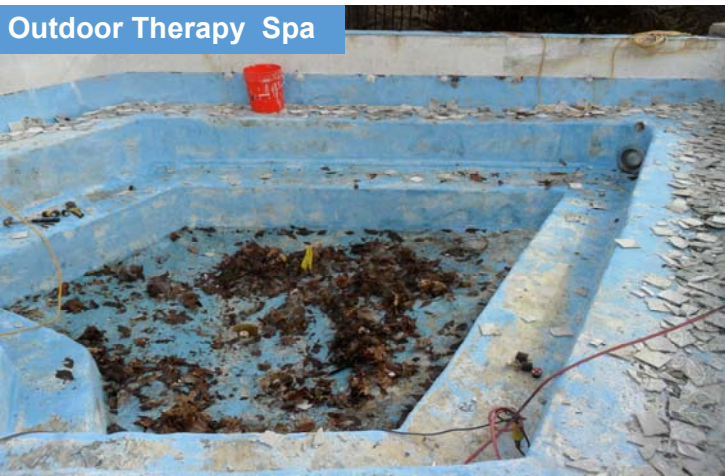
the heated outdoor therapy spa’s grey concrete

shown through the peeling surface material making the vessel appear as though it was constantly dirty. A structure crack developed through one wall of the spa allowing spa water to freely drain on to the sidewalk.

Outdoor Therapy Spa

Paint and other failing surfacing materials on the outdoor spa were completely removed down to a sound concrete base. In addition to repairing a structure crack in the spa wall, several broken and compromised recirculation and air lines had to be removed and replaced.

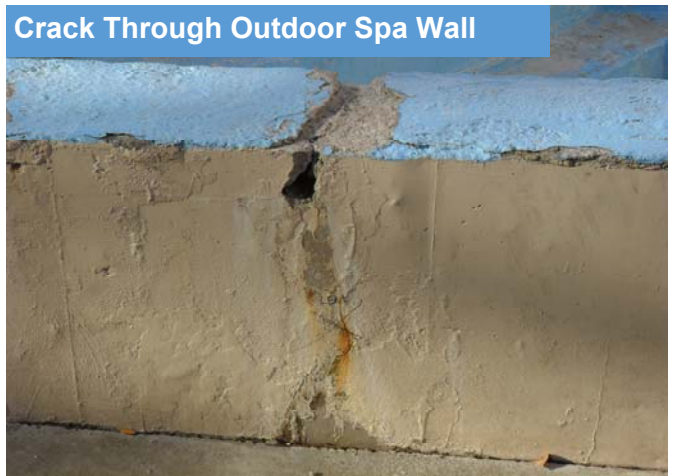
Crack Through Outdoor Spa Wall

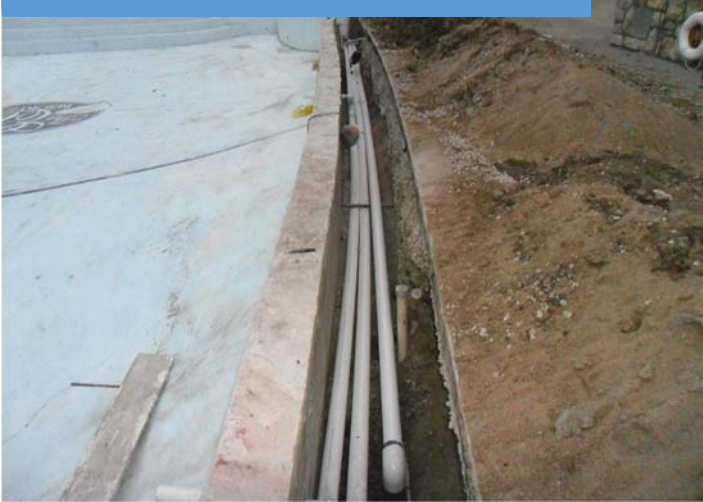
**New Recirculation Lines in the Trenches**

Beginning progress on the outdoor pool and spa simply meant a lot of demolition, removal of layers of pool paint and poor surfacing materials. Fill soil below a wide concrete coping apron allowed for a 'ready' space for new plumbing lines. Excavation to the Frost Depth level and installation of SCH 80 PVC lines set the stage for a long term recirculation line-life. Environmentally friendly hydro-blasting (Ultra High Pressure Water-Jetting) was used to remove pool paint and deteriorated concrete. Exposed rusted and degraded metal recirculation lines and metal light conduits were removed. New recirculation lines, and

skimmers were installed and put under pressure through-

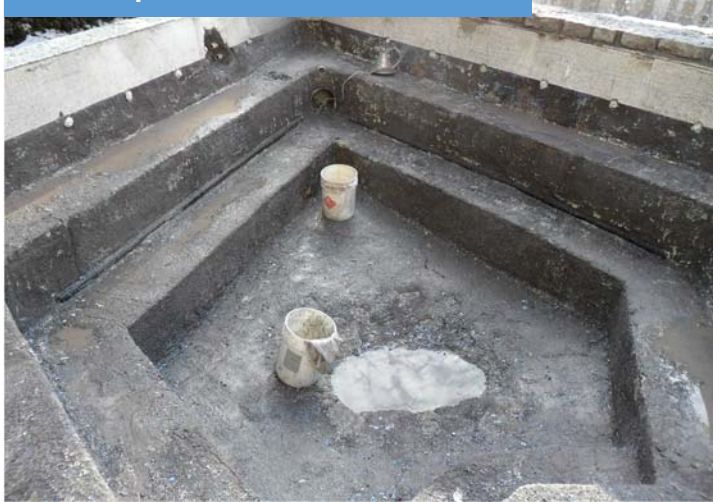
**Gutted Spa to Sound Concrete Base**

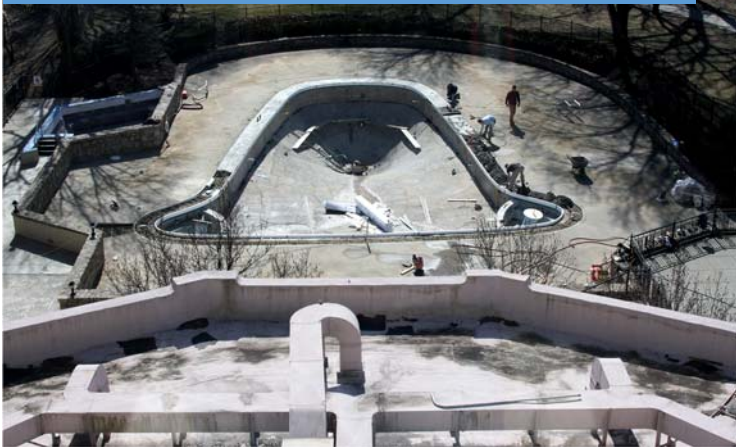
New Concrete Cantilever Placement in Progress

Aqua colored waterline tile was installed around the top of the main pool. Forms were attached to the tile and a new concrete cantilever was set into place along with frost-proof depth and No Dive tile. A non-skid, tan colored textured finish was installed over the concrete cantilever. The indoor pool and spa did not have structural issues. Aqua colored waterline tile and like colored Diamond Brite® was the material of choice on the indoor vessels.

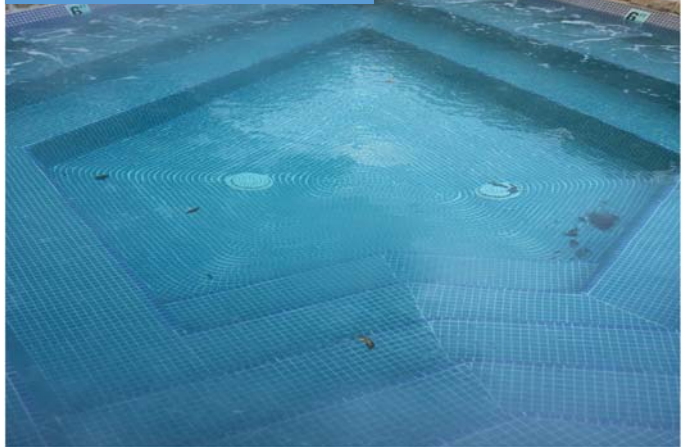
Outdoor Fully Tiled Spa

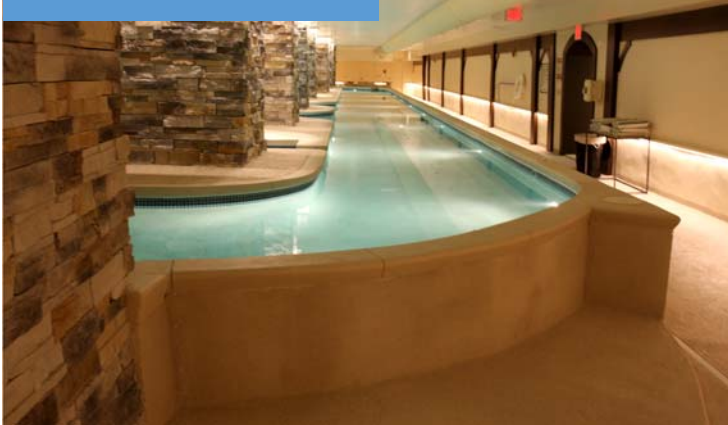
Restored Indoor Lap Pool

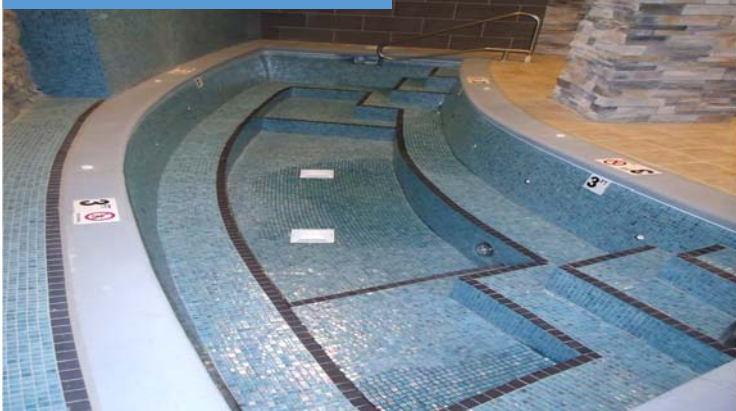
New Fully Tiled Grotto Spa

A new, large shot-crete therapy and relaxing spa was constructed in the new Grotto area. Using the Laticrete® tile installation system, this new vessel received a fully glass tile finish, new heater, filter and equipment.

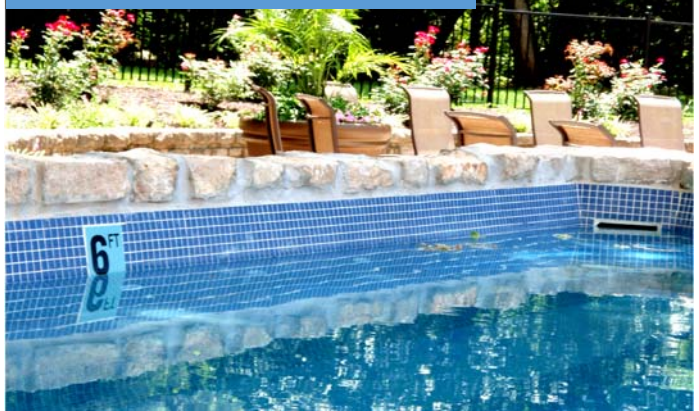
Revamped Natural Rock Coping
